Empress of the North

Temporary Repair Plan

(Prior to transit from AK to OR)

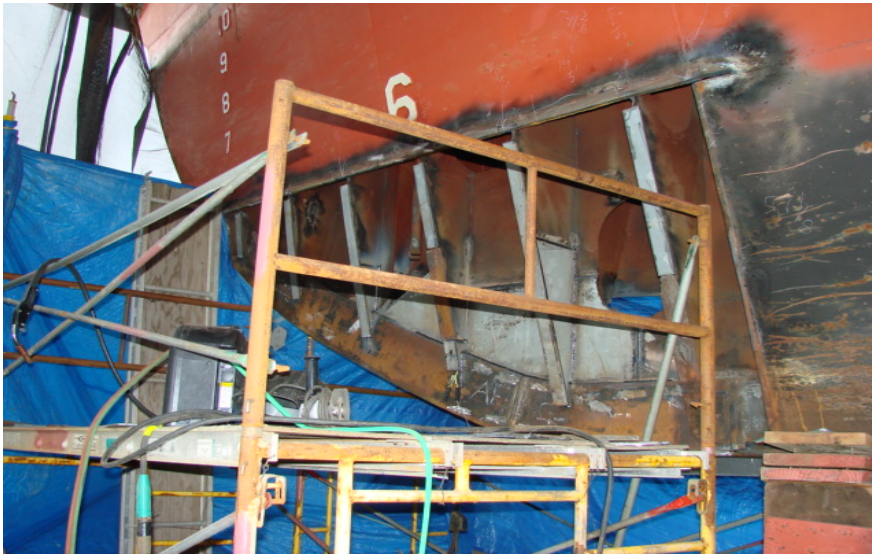
Centre line girder and frames fitted and being welded on the Stem.

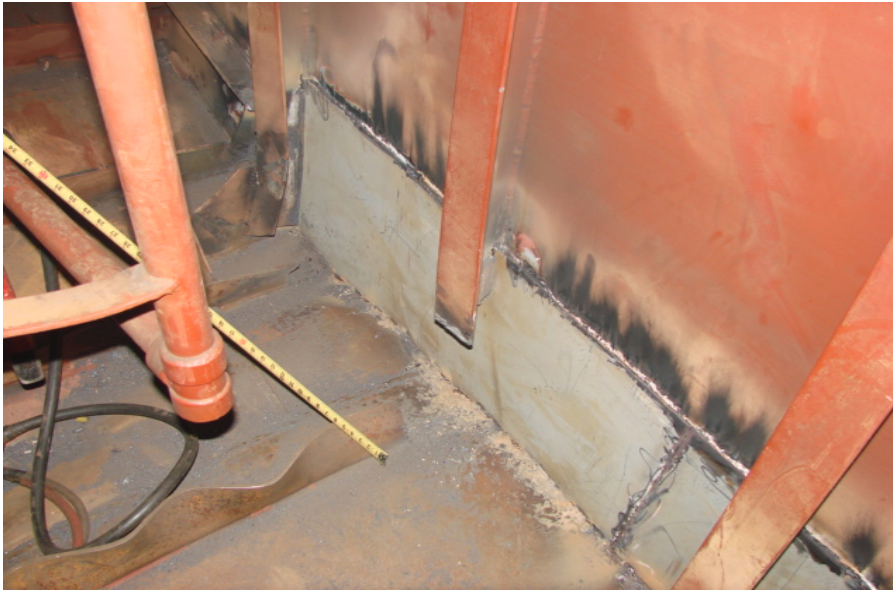
Bulkhd insert fitted on Frm 37 between FO and Ballast tanks. Additional stiffening will be fitted to support badly depressed bottom plate iwo of frames 43 and 39.

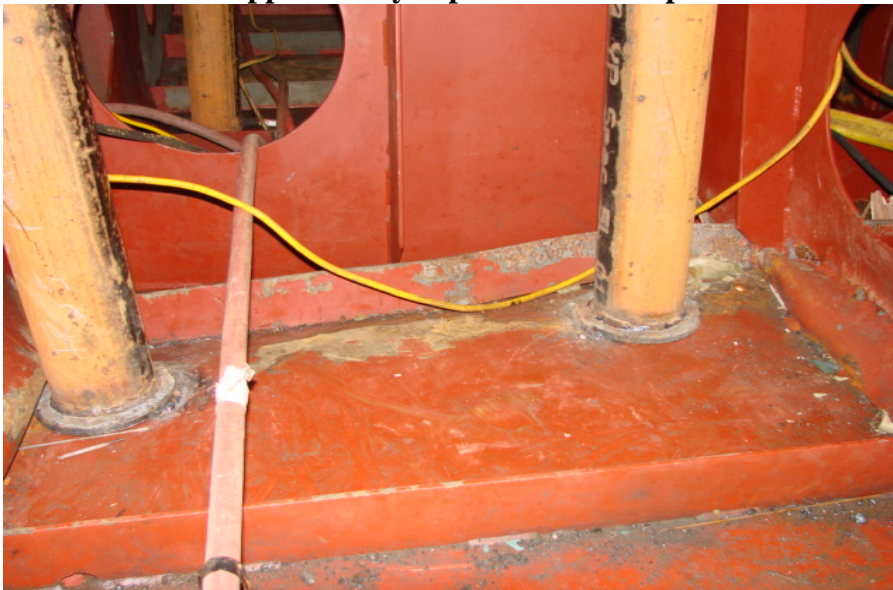
20 pieces of Pipe stays made and fitted between the bottom plate and the Suspended FW tanks iwo of fuel oil tank and Void 1, between port and Stbd longi girder. More are being fitted.

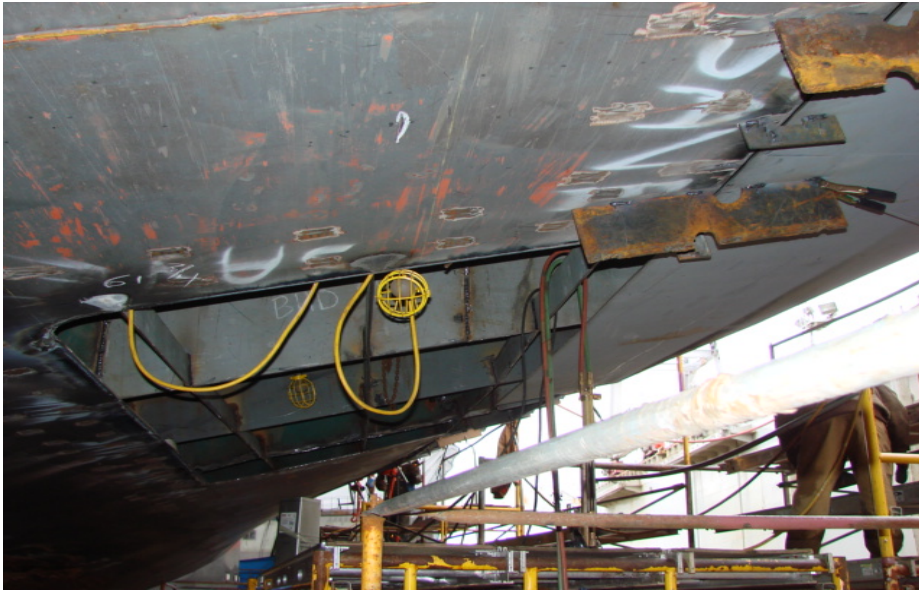
Bottom plate inserted at the Chine between Frms 57-53, 53-46 and 37-30

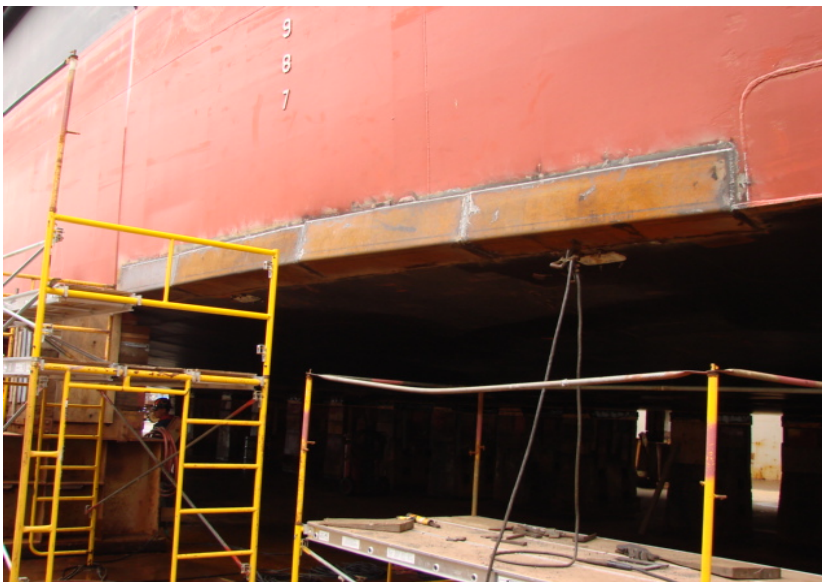
Doubler welding on the aft Chine damage, Frm 69-80 completed.

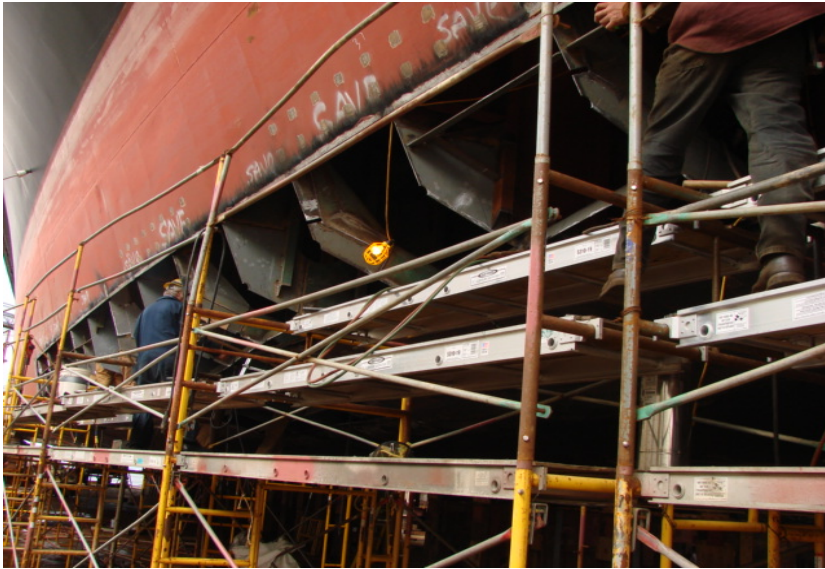
New frames and flat Bar longis fitted in Fwd Chine damage, Fr.30-57

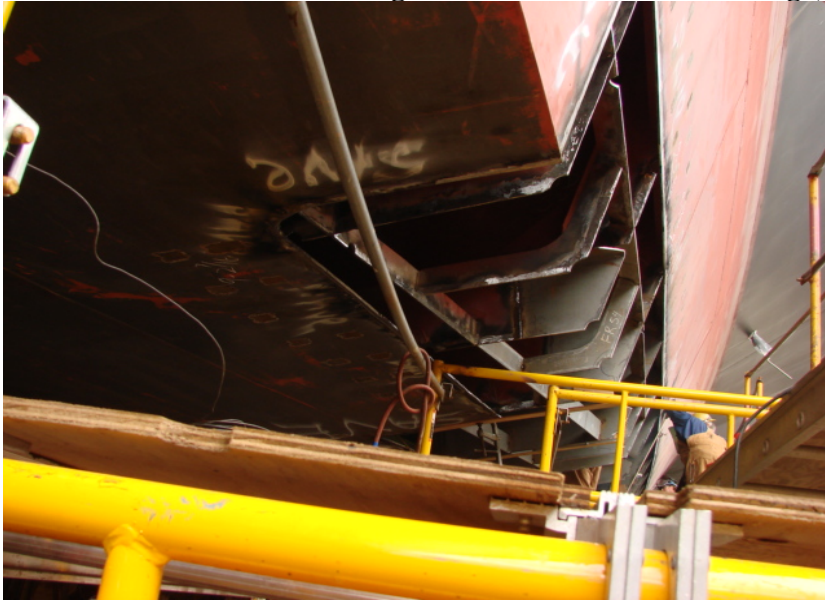
Bottom Plate ready to be fitted in place tonight between Fr 53-57.

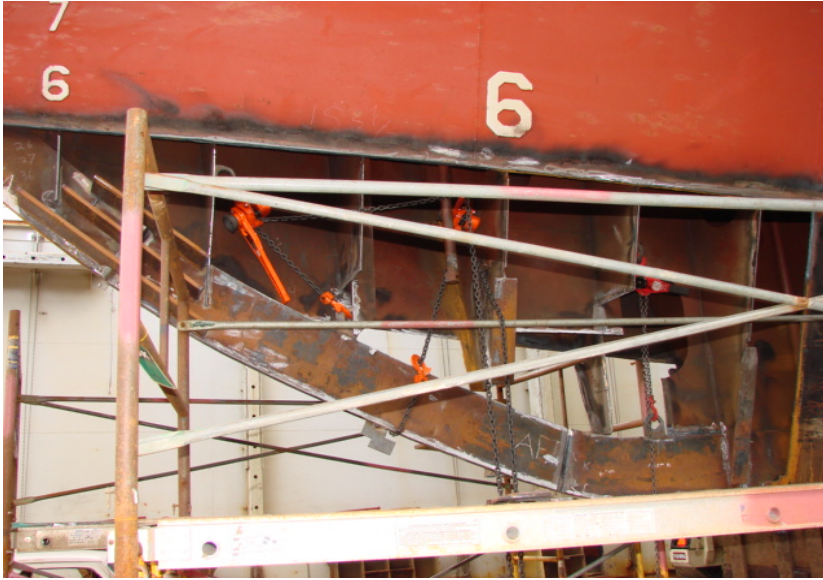
Fwd Stem Bar positioned and internals being prepared.

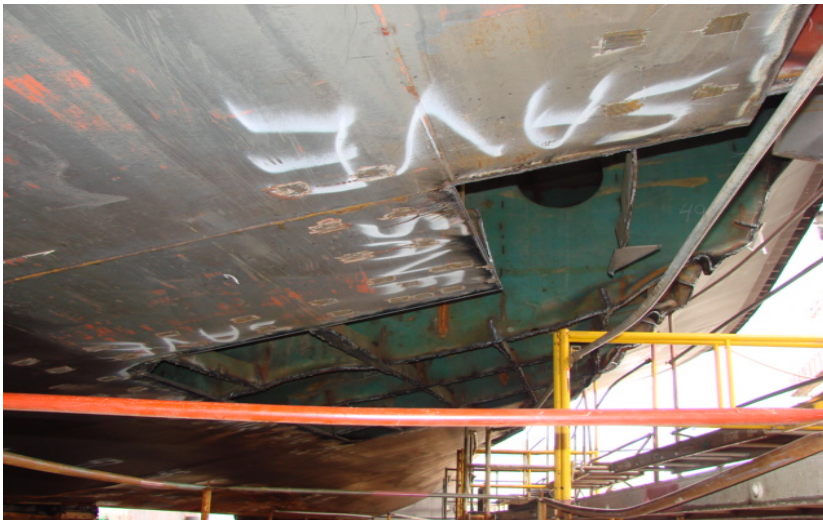
B Strake plate cut out between Fr. 43-51

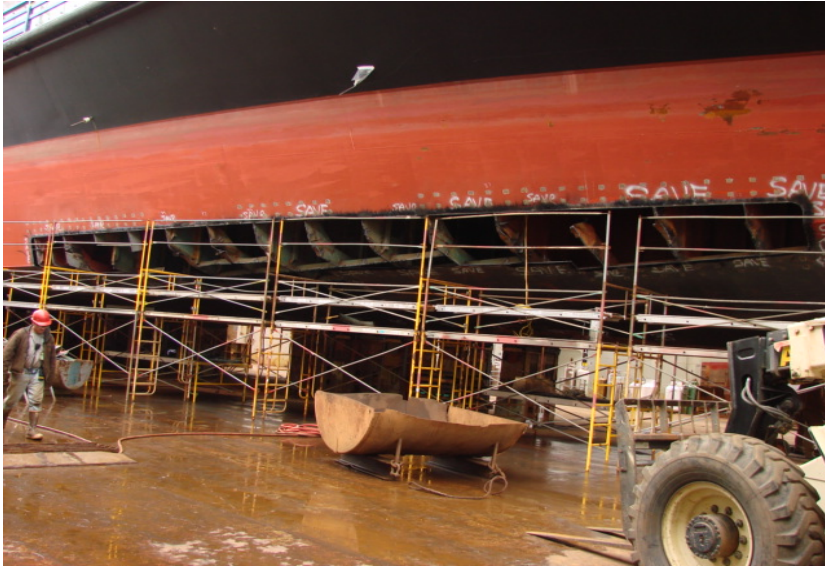
Fwd Chine plates between frms 28 and 57 fully cut out, including the plate in B strake between Fr.43 and 51.

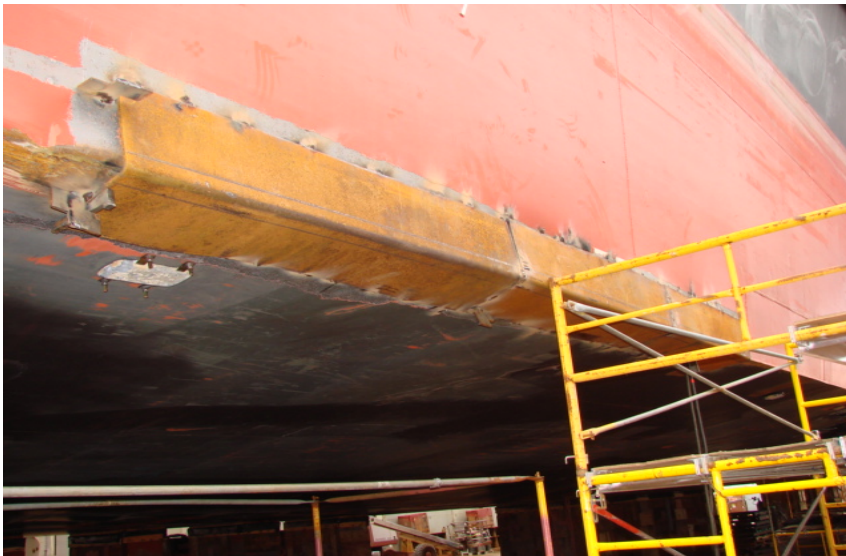
Doubling plate put on the Chine iwo of Fr 69 and 78

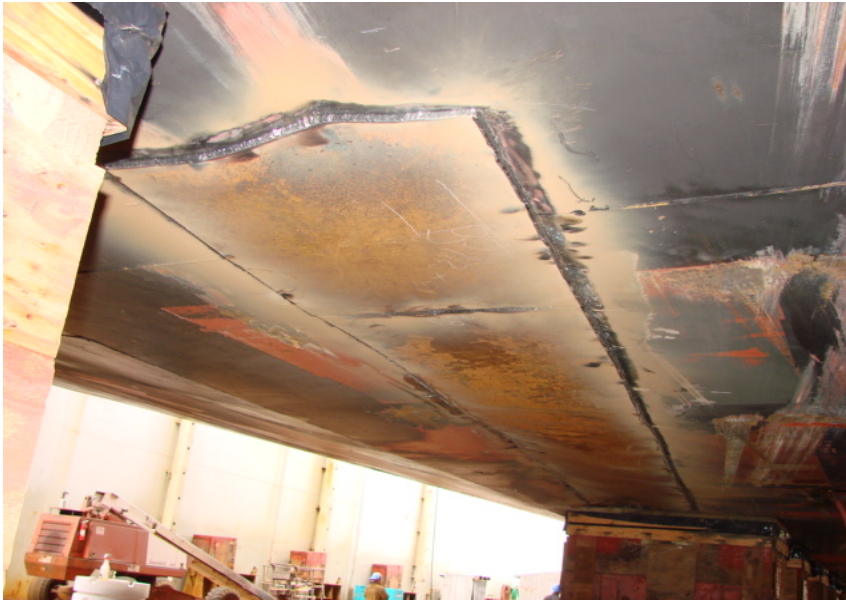
Doublers put in place on KP between frms 55 and 61.

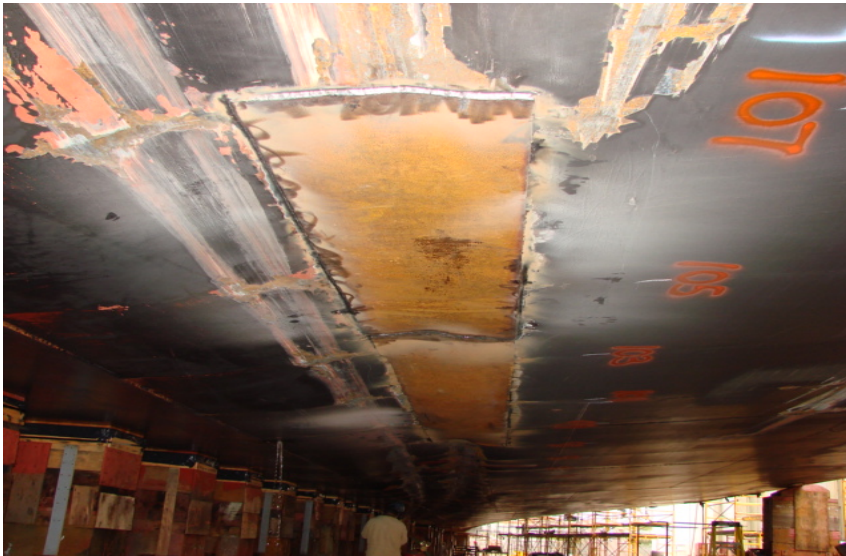
Doubler on Strake B between Frms 107 and 99 iwo void 3.
